## Ensure your Secondary Containment isn't a False Sense of Security

## Wastewater Pit Upgraded with New Coating System

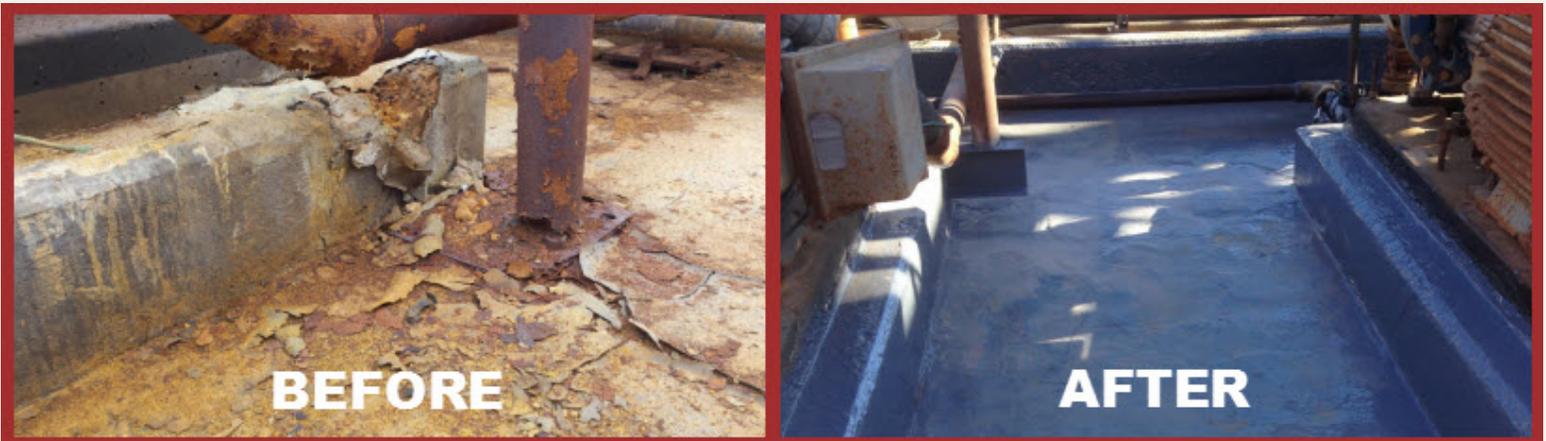
Due to the air and moisture it contains, concrete is a "living, breathing animal" that presents coating challenges. Goodwest Linings & Coatings is intimately familiar with the [key steps](#) required to successfully prepare and coat concrete surfaces:

- Coating system engineering for optimum chemical resistance and successful installation
- Moisture testing
- Hydro-cleaning and abrasive blasting
- Decontamination and pH neutralization
- Re-surfacing of degradation, spalling, and bugholes
- Bridging of cracks and expansion joints
- Surface temperature management to reduce off-gassing.

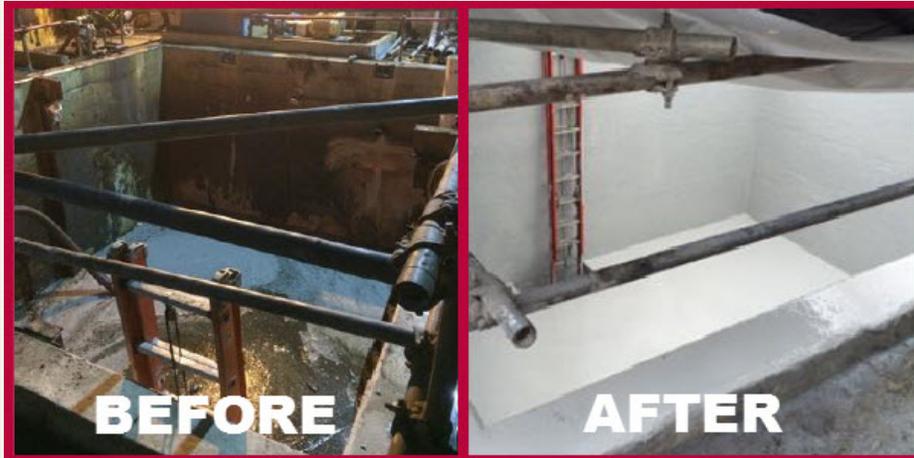
Goodwest prepared the concrete surfaces by performing a high-pressure rinse and de-greasing, followed by an abrasive blast per SSPC-SP-13 to remove the existing coating and open up the concrete. CarboGuard 510 mortar repair was then used to resurface irregularities and fill voids.

Goodwest wanted to minimize outgassing to ensure Steelscape's coating system would last for years. They reduced porosity by applying a sealer called Semstone 110. Finally, the pit was coated with Plasite 4550, a 100% solids flake-filled novolac epoxy, at 60 mils DFT.

Steelscape now has a quality coating system in their wastewater pit that will provide a long-term solution. They were very pleased with Goodwest's efforts.
