Goodwest Coats Desalination Tanks for Australian Natural Gas Field

The Forms of Corrosion that may Affect Your Assets

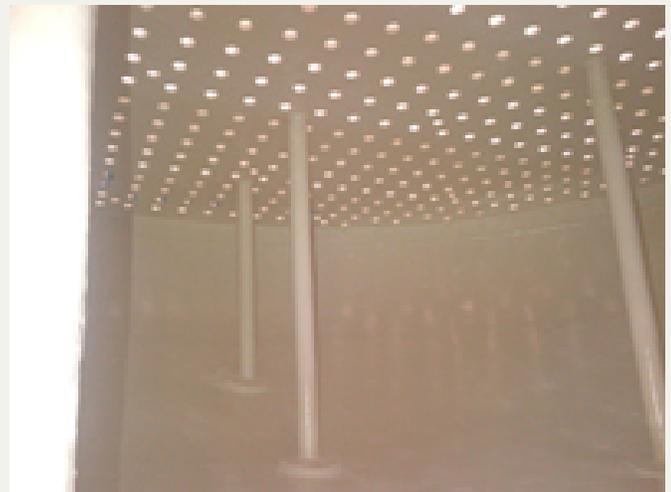
The equipment included three 15’ diameter x 27’ high pressure vessels that weighed more than 50,000 lbs. each. The interior steel configuration was extremely complex (*see photo*) which made a pinhole-free lining installation difficult. One tiny pinhole in the lining can lead to vessel failure within one year in seawater.

Goodwest engineered and installed an elastomeric polyurethane lining using the patented [ECOSYSTEM®](#) gas-expanded technology to create a 1/4” thick barrier between the saltwater and steel. This technology allows for thick-film buildup in a single coat on complex steel structures.

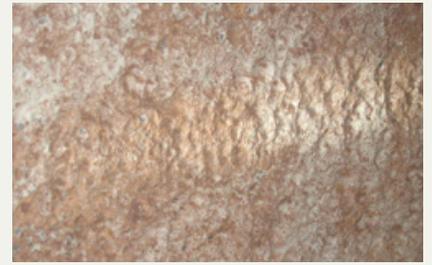
Uniform Corrosion

Uniform corrosion is when metal loss is spread evenly across a large area that is exposed to whatever is causing the chemical reaction (ie. saltwater, oxygen, etc.). Individual pits are not necessarily deep, but if left unchecked, can ultimately compromise a structure's integrity.

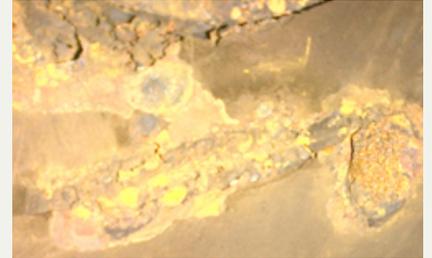
Localized Corrosion Pitting

Pitting usually occurs when there is a breach in an interior lining system. All of the electrical potential is focused on that precise spot, resulting in an exponentially higher rate of corrosion than if all of the steel were exposed.

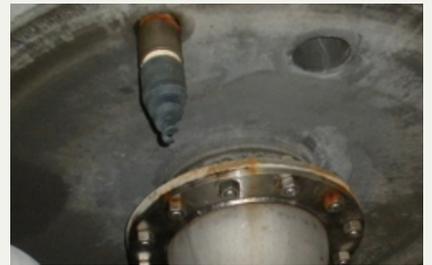
Galvanic Corrosion

Galvanic corrosion occurs when two dissimilar metals come into contact under water. An interesting electrical reaction occurs at the seam of the two metals: one of the two metals speeds its corrosion process, while the other corrodes more slowly.

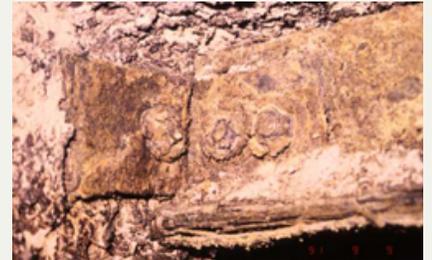
Lamellar Corrosion

This type of corrosion generally appears on exteriors where the surface has been allowed to corrode for some time. Layers of corrosion pull the metal away from the body of the material. The name Lamellar refers to the thin flat layers of corrosion, which are sometimes referred to as scales.

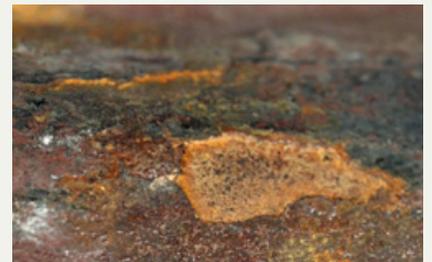
Erosion Corrosion

This is an acceleration of the rate of corrosion in metal due to the relative motion of a corrosive liquid on the metal's surface. This type of corrosion can lead to pitting, which then exacerbates deterioration.

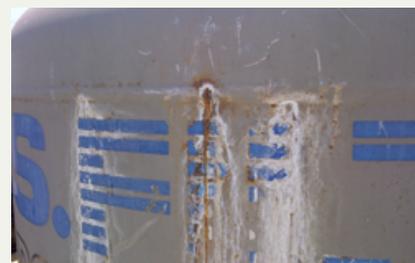
Stainless Steel Corrosion

Steel is not the only metal that corrodes—others do as well, just in different ways. When exposed to chlorides (ie. saltwater), stainless steel corrosion causes microscopic pits and cracks that are often not visible to the eye but can still cause extensive damage.
