## Welcome

This is Goodwest Linings & Coatings' first newsletter. Our goal is to provide information about the corrosion protection industry while showing real client examples of how our products are improving infrastructure.

## Elastomeric Polyurethane Linings Extend Life Span of Pressure Vessels

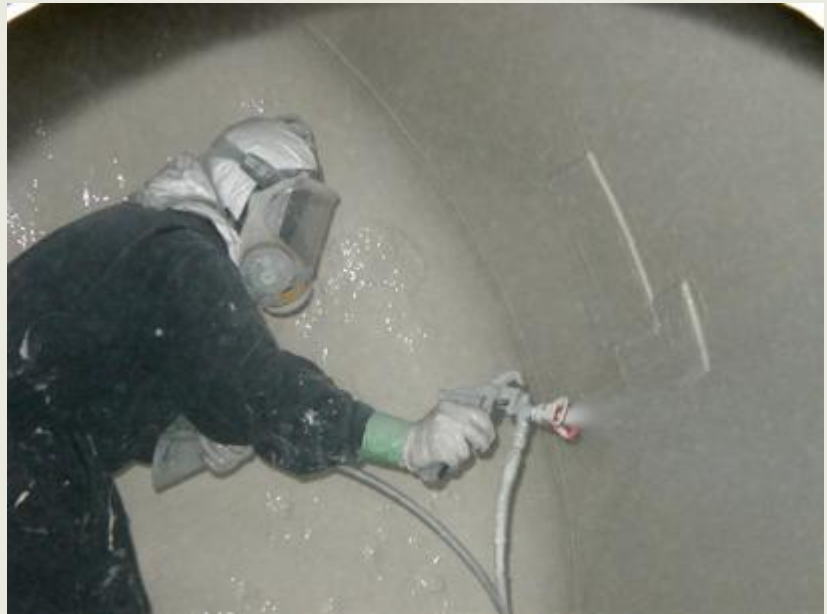
*Goodwest employee relining a severely corroded water filtration pressure vessel with thick film of elastomeric polyurethane.*

Ten years ago Goodwest Linings & Coatings decided to try something that had not been attempted before on the west coast – lining water filtration pressure vessels with elastomeric polyurethane. More than three hundred filtration vessels later, the verdict is in: elastomeric polyurethane linings ensure long-term, maintenance-free corrosion protection of vessels and significantly extend the lifespan of water filtration systems.

Elastomeric polyurethane linings can be applied as thick as ¼" in a single coat, virtually eliminating chances for pinholes to form over welds, sharp edges, corrosion pits, and other irregular surfaces where corrosion usually occurs. As one carbon filtration customer using Endura-Flex 1988 elastomeric polyurethane puts it, "We've tried different linings and elastomeric polyurethane is by far the most durable and reliable. We have a rental fleet and we're protecting our investment for the long term with this lining."

Goodwest has inspected hundreds of failed pressure vessel linings and we know first-hand how the electro-chemical environment inside most filtration vessels can dramatically increase the rate of corrosion at any pinhole location. It's therefore critical to use the lining that offers the least chance of a pinhole forming in the future. The thick, tough film of elastomeric polyurethane offers excellent abrasion resistance to media filling, removal, and back-flushing, while also providing impact resistance when internal piping is installed,
