New Breed of FRP Tankers Hitting the Road

International Mining Project Seeks Long-Distance Solution

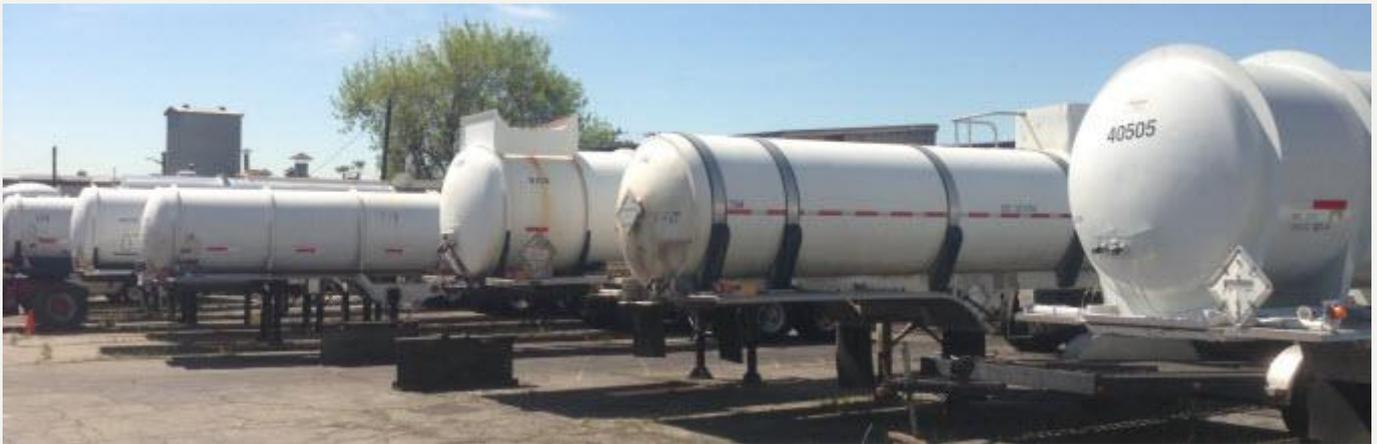
A chemical transportation company recently contacted [Goodwest Linings & Coatings](#) to see if their 5,000 gallon FRP tankers used to transport bleach could be rubber lined. The answer? "Of course!"

When the tankers arrived at the [Goodwest facility](#), the existing composite resin linings were degraded, flaking off, and in a word: failing. The experienced team at Goodwest knows very well that companies are losing money while their equipment is out of service. So they quickly and effectively removed the failed lining and installed a 1/4" thick pure chlorobutyl rubber lining in each of the tankers.

As any diligent chemical transportation company would, they periodically inspect the rubber linings in their tankers. Adhesion to the FRP substrate has remained good with no blistering and the seams/cap strips are intact. The president of the company has since paid Goodwest the biggest compliment possible: He placed more orders to have his FRP tankers lined with chlorobutyl rubber!

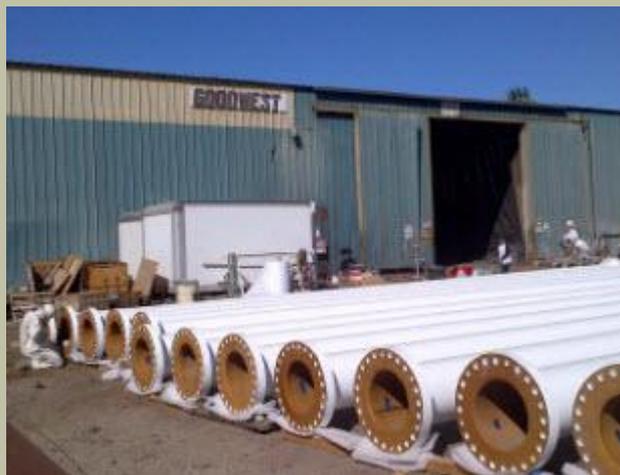
A billion dollar mining construction project in Mexico required more than two miles of 20" diameter rubber-lined pipe for their process water. The pipe for this project was to originate from a major distributor in Southern California. Goodwest Linings & Coatings was selected to install the rubber lining and exterior coatings.

In a growing trend in the mining industry, the mine's process water was derived from the ocean. The corrosive nature of saltwater, the abrasiveness of the slurry, and the high-pressure due to the water being pumped all the way from the sea, made for a very abusive environment. Fluor engineers decided to specify a thick soft rubber lining for the job.

The 50 ft. pipe lengths were not an obstacle due to [Goodwest's 60 ft. steam autoclave](#) for pressure curing of the rubber lining. Goodwest also applied a 3 coat exterior coating system in their large spray booths.
